## Polaris Faces Flooring Challenge

Published on Industrial Maintenance & Plant Operation (<http://www.impomag.com>)

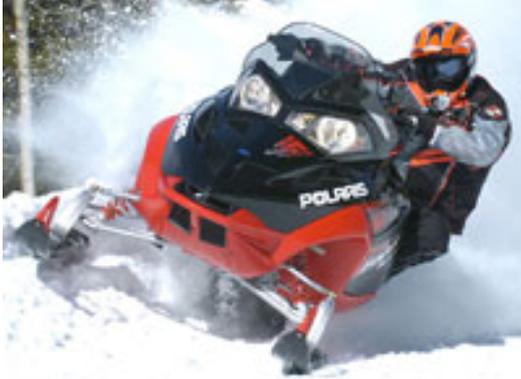
**Polaris' Roseau, MN facility houses both its high-tech product testing lab and manufacturing operations for ATVs, snowmobiles and Ranger UTVs**

**Polaris** manufactures heavy-duty vehicles that require heavy-duty testing

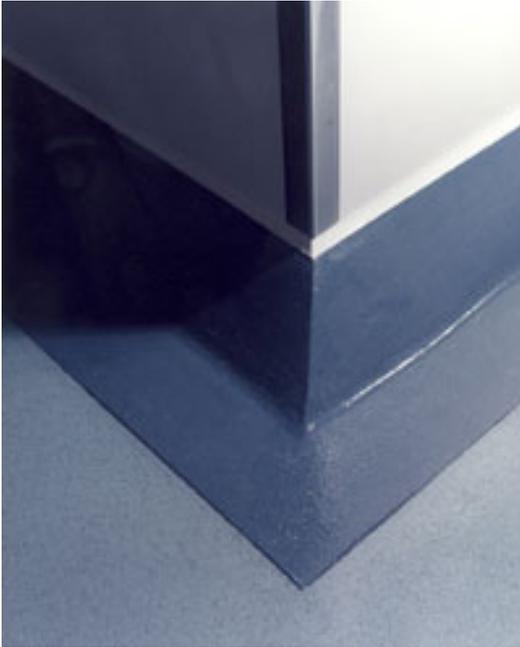
"The Sika flooring has proven to be durable, simple to clean, and stain-resistant," says Polaris project coordinator, **Deland Broten**.

**Sika** [2] Quartzite systems blend ceramic-coated quartz grains with a clear polymer matrix, creating a wide range of finishes and textures.

Sika sales engineer, Bryan Godmare, recommended to Broten that Polaris install Quartzite™ 6000 Decorative Quartz Flooring Systems. The nominal 1/8 in. double broadcast floor system consists of 100 percent solid clear epoxy and multicolored, fine grain, ceramic-coated quartz aggregate that produces a soft, varied tweed pattern.
