# Loading-Dock Seal Fires: Why They Occur, How to Prevent Them

Chuck Ashelin, Engineering Manager, Frommelt Products Corp.

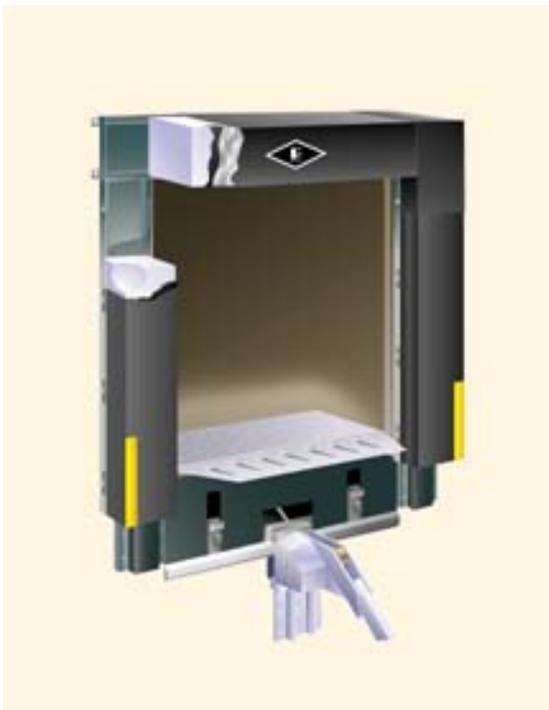
*Frommelt's new dock-seal design uses metal foil to dissipate trailer-light heat.*

Though many fireproof materials are commercially available, none possessed the combination of strength, abrasion resistance and heat resistance that would allow a simple substitution of fabric on a dock seal. In Frommelt's effort to gain fire resistance, the company used fabrics designed for high-wear reliability that would still mitigate the issue of temperature buildup from trailer marker lights. Its Firefighter head pad is designed to dissipate the heat generated before it can build to dangerously high levels. The approach is accomplished by using three layers of reinforced heavy-duty metal foil, sandwiched between inner and outer layers of vinyl compound-coated fabrics, all covering a fire-retardant polyurethane foam block. The triple layer foil acts as a heat sink. It absorbs heat generated by the marker light, and dissipates it across the entire surface of the pad, instead of allowing heat to build in a small area. Tests showed that when the Firefighter head pad was exposed to hot trailer marker lights, the surface temperature remained below 440° F, well below the temperature at which the foam can auto-ignite.
